NASA CR-72966
R-8494-2

ROTATING AND POSITIVE-DISPLACEMENT PUMPS
FOR
LOW-THRUST ROCKET ENGINES

FINAL REPORT
VOLUME II
FABRICATION AND TESTING

ROCKETDYNE DIVISION
ROCKWELL INTERNATIONAL
CANOGA PARK, CALIFORNIA

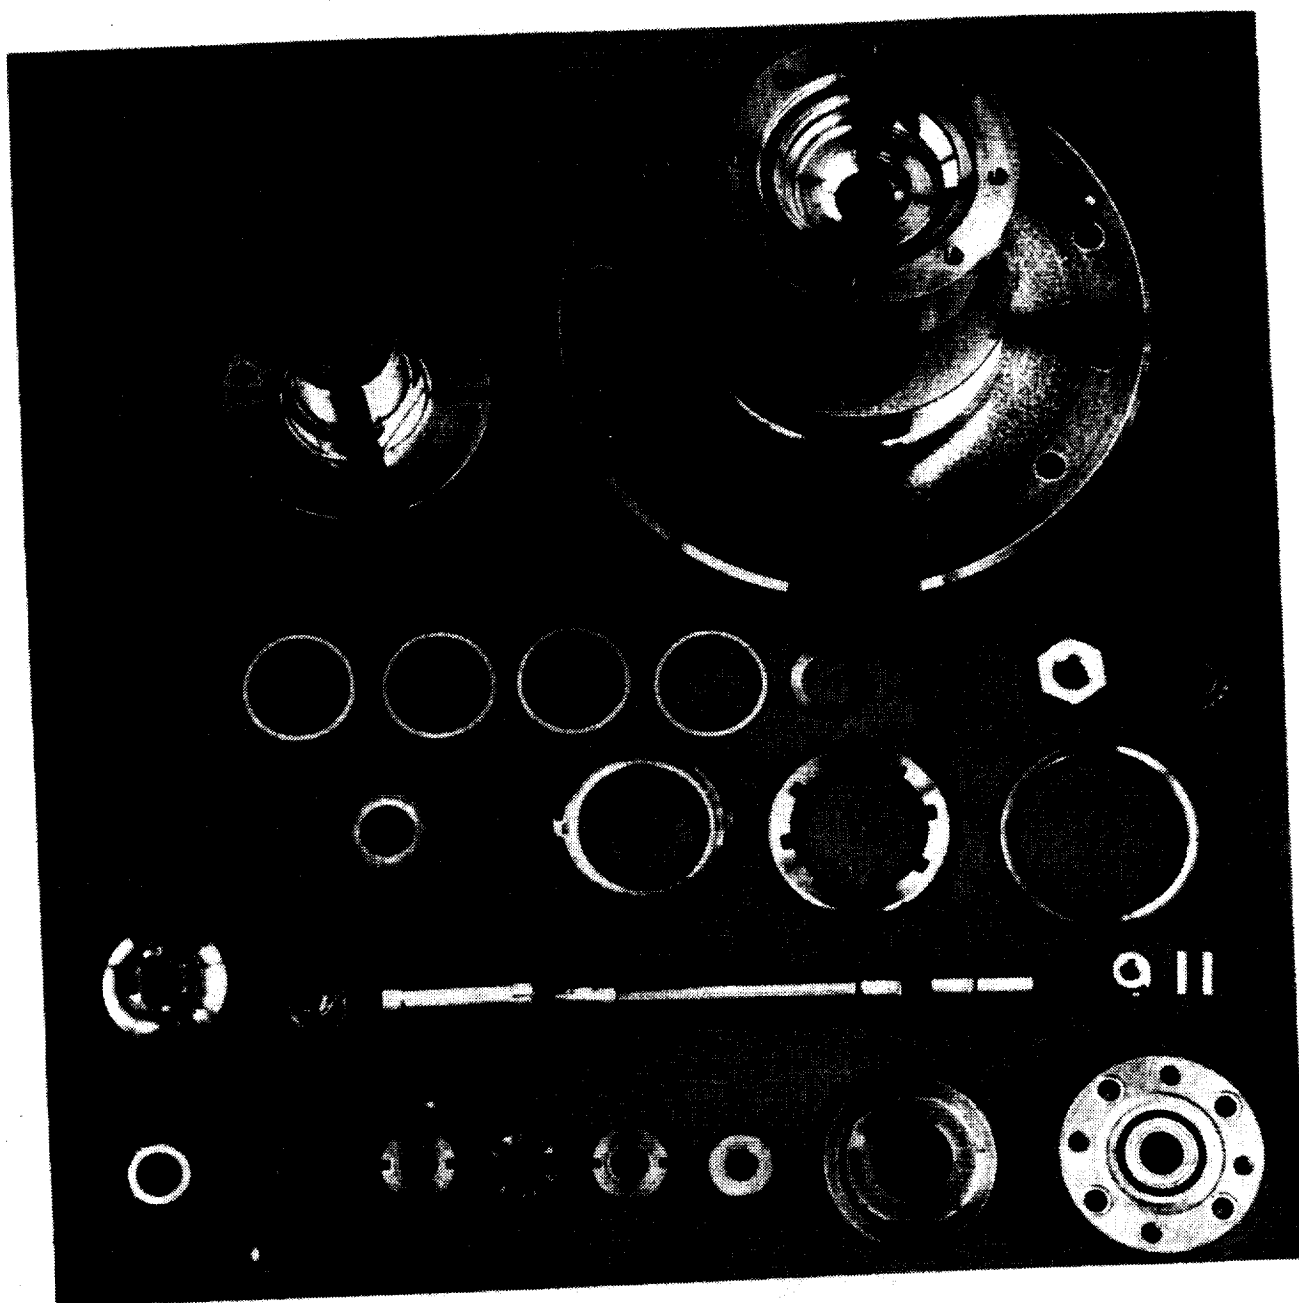
1XY52-3/16/70-C1

Figure 1 illustrates the detail parts of the centrifugal pump prior to initial assembly. The drive turbine components are not included in this photograph.

Figure 1. Mark 36 Centrifugal Pump

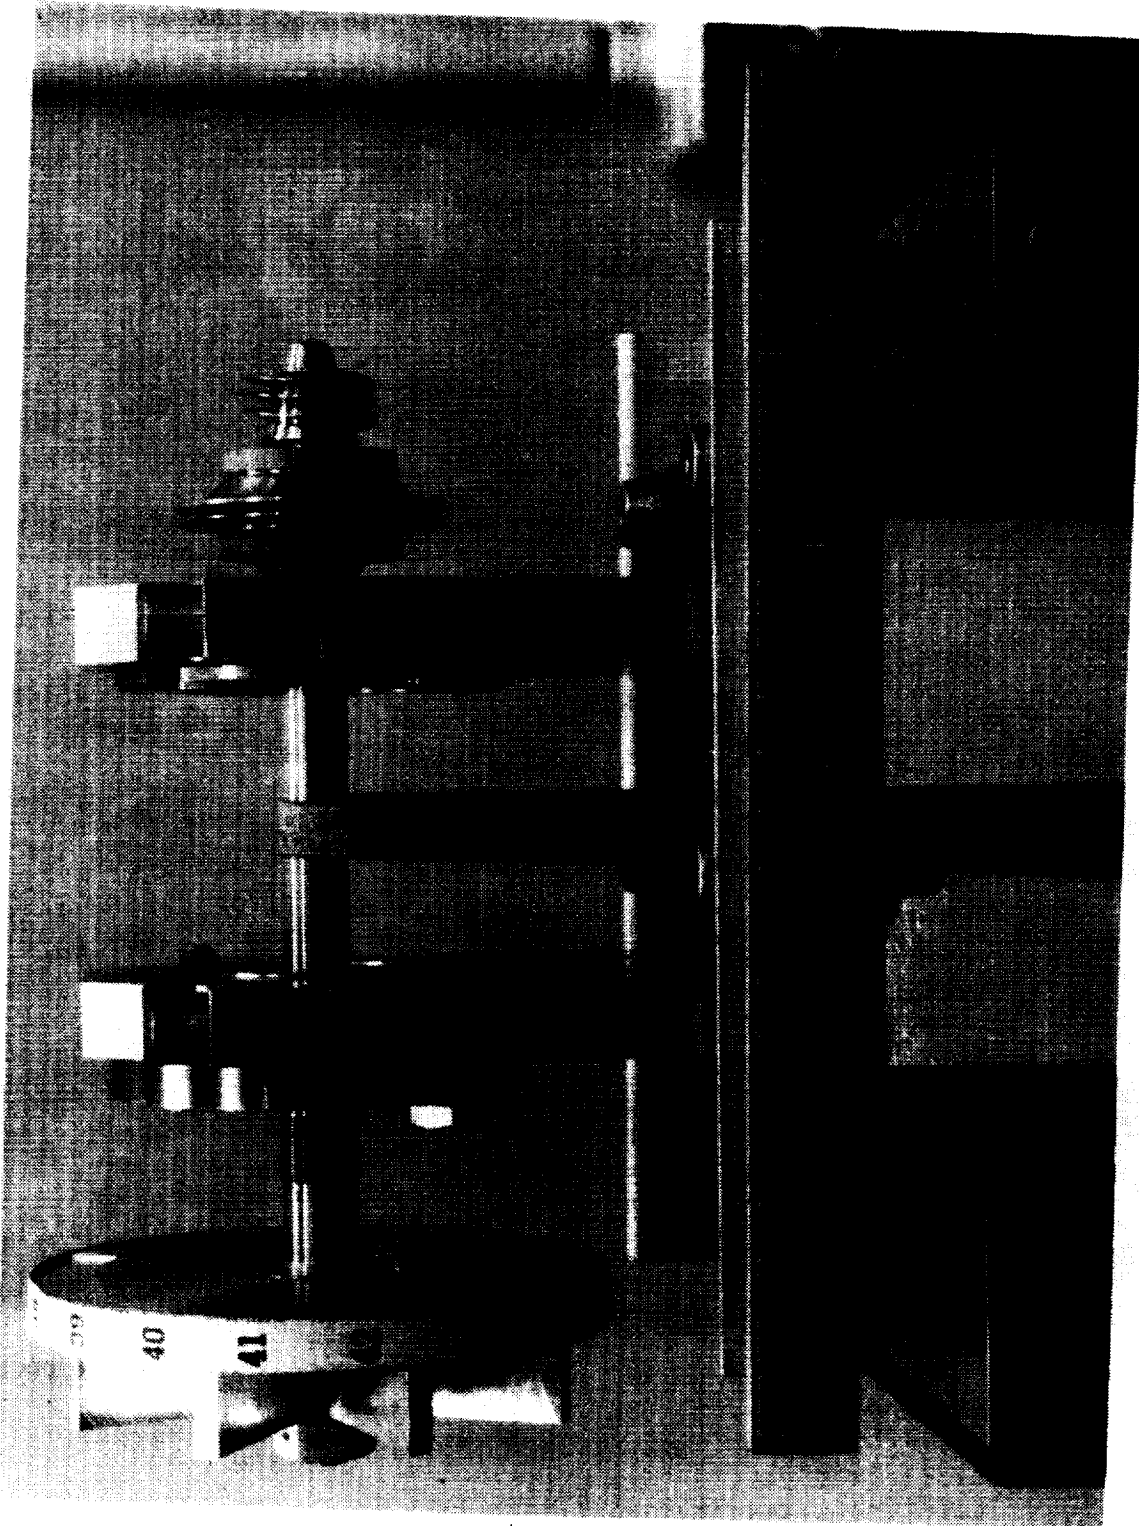
IXY92-5/20/70-C1A

Balancing of the rotor assembly was accomplished on a Gisholt Type U-11-1113 balancing machine at a speed of 2950 rpm. Figure 2 and 3 illustrate the installation of the rotor in the balance machine. Components of the rotor assembly which are not fixed in angular position relative to the shaft, such as the inducer and impeller retaining nut, were individually check balanced and corrected as required. Final two-plane balance correction for the complete rotor assembly was effected by removing material from the impeller, inboard of the rear wear ring, and from the tips of the turbine disk vanes. The residual unbalance was reduced to the machine limit which, for a rotor of this size, is approximately 0.01 gm-in. (0.0249×10^{-6} N-m).

Figure 2. Mark 36 Pump Balance Assembly

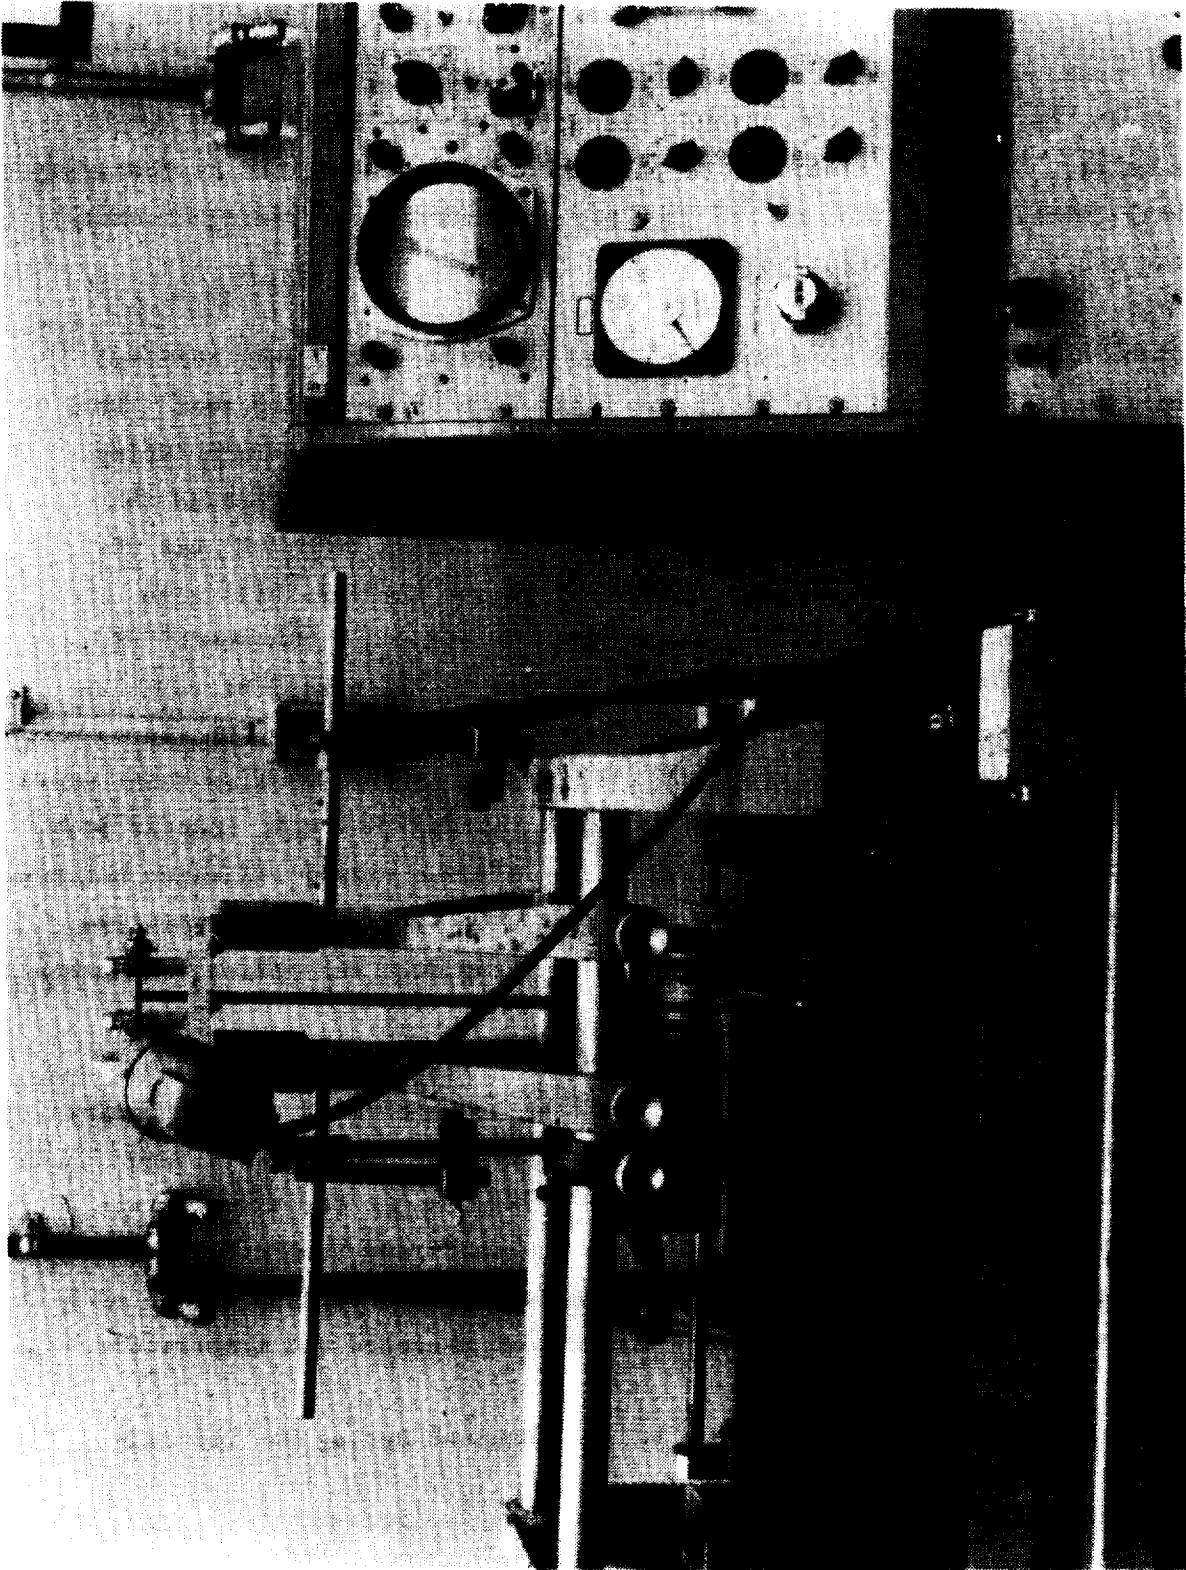
1XX92-5/20/70-C1B

Figure 3. Mark 36 Pump Balance Assembly

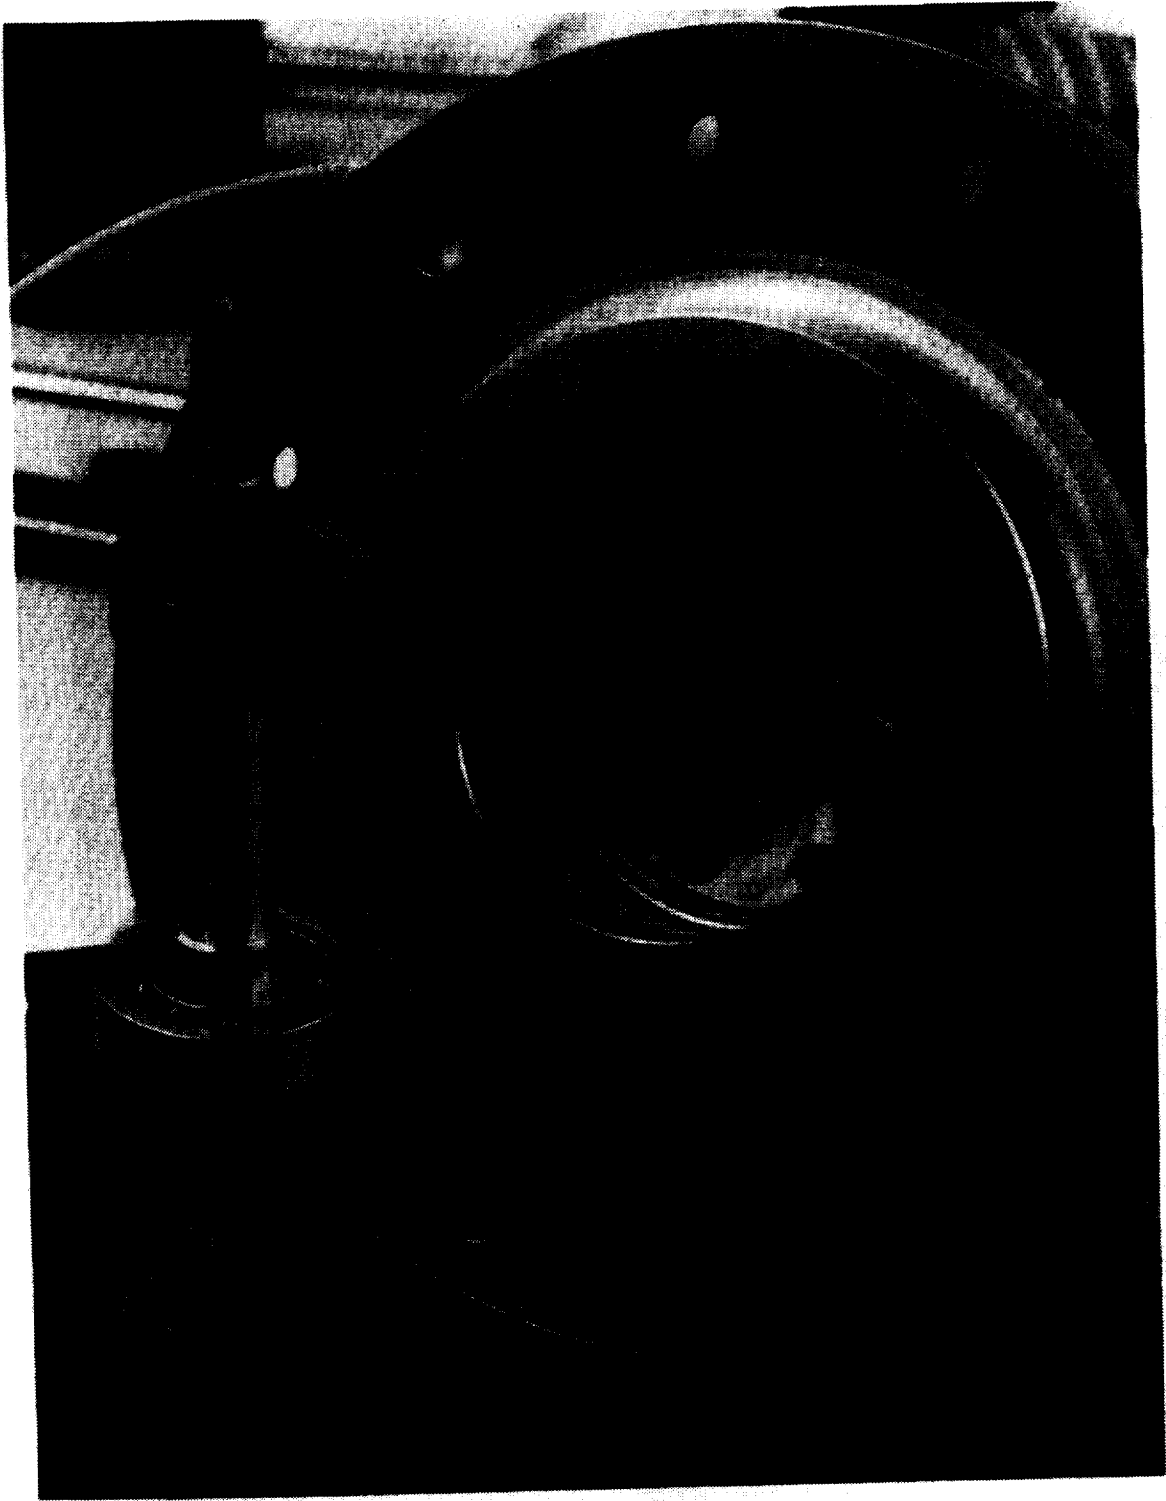
1XY55-6/23/70-C1K

The actual buildup of the pump was initiated by pressing the rear bearing, bearing spacer, and front bearing on the shaft with an hydraulic tool. This rotor subassembly was then installed with the front bearing preload spring in the volute housing (Fig. 4), and the thickness of the shim behind the spring was adjusted until a bearing preload of 60 pounds (266.5 N) was obtained. Subsequently, the primary, intermediate and turbine seals were installed, with appropriate flange seals (Fig. 5 and 6). The runout of the volute wear-ring inner diameter, with respect to the center of rotation of the shaft, was measured, after which the impeller was pressed on the shaft with an hydraulic tool (Fig. 7). The runout of the impeller front wear ring was verified, followed by installation of the impeller nut, inducer lock, inducer (Fig. 8), and the inlet housing. The minimum radial clearance between the inducer tip and inlet housing was measured with wire gages; the minimum wear-ring clearances were calculated by subtracting from the nominal clearance the measured run-outs.

Figure 4. Mark 36 Centrifugal Pump Installation of the
Shaft-Bearing Subassembly

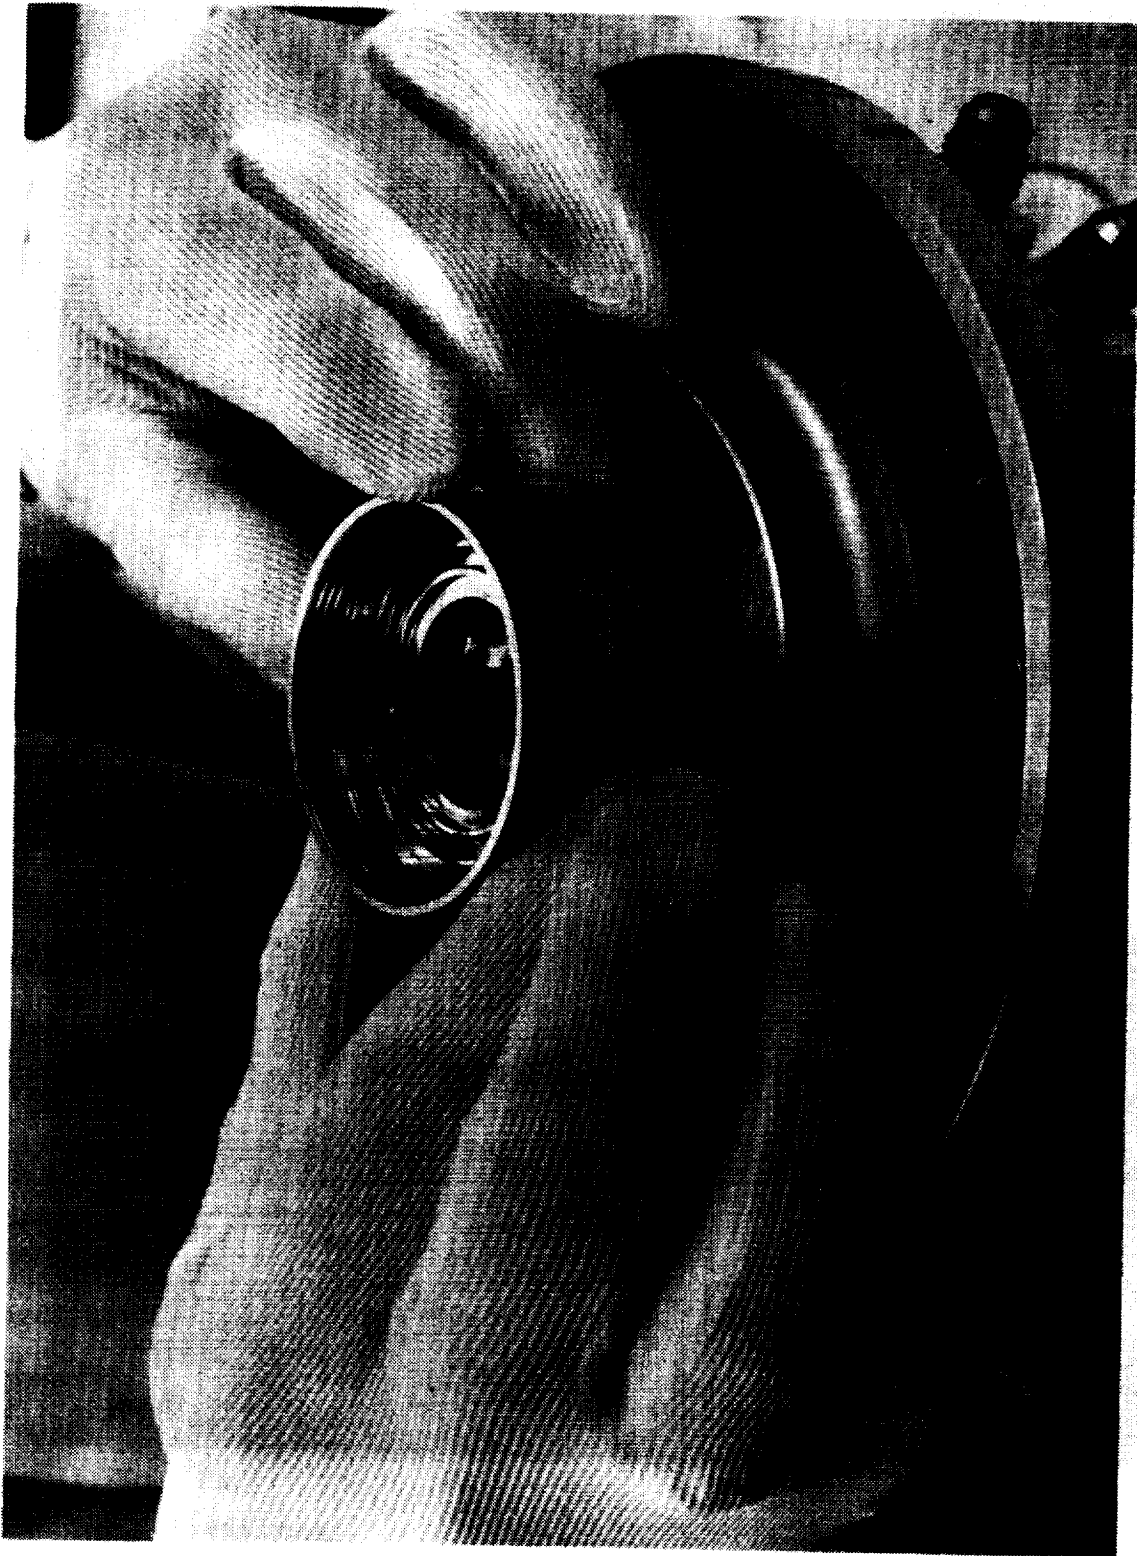
IXY55-6/23/70-CIE

Figure 5. Mark 36 Centrifugal Pump Primary Seal Installation

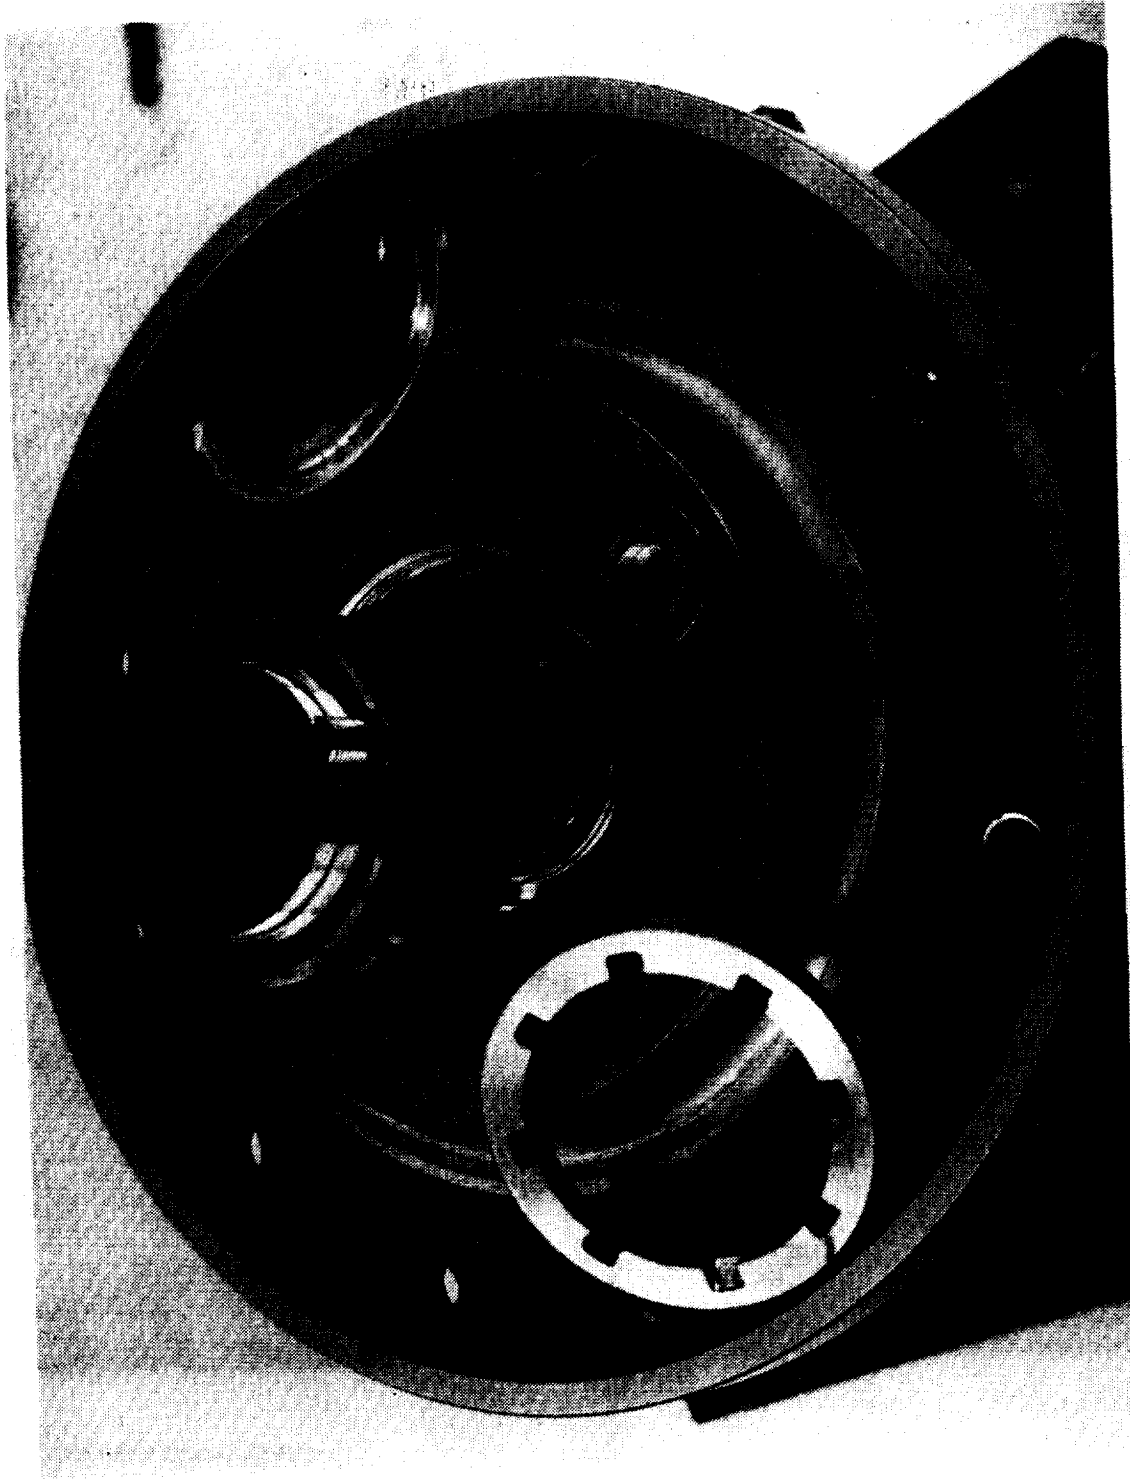
1XY55-6/23/70-C1C

Figure 6. Mark 36 Centrifugal Pump Intermediate Seal Rings Installed;
Turbine Seal Ready for Installation

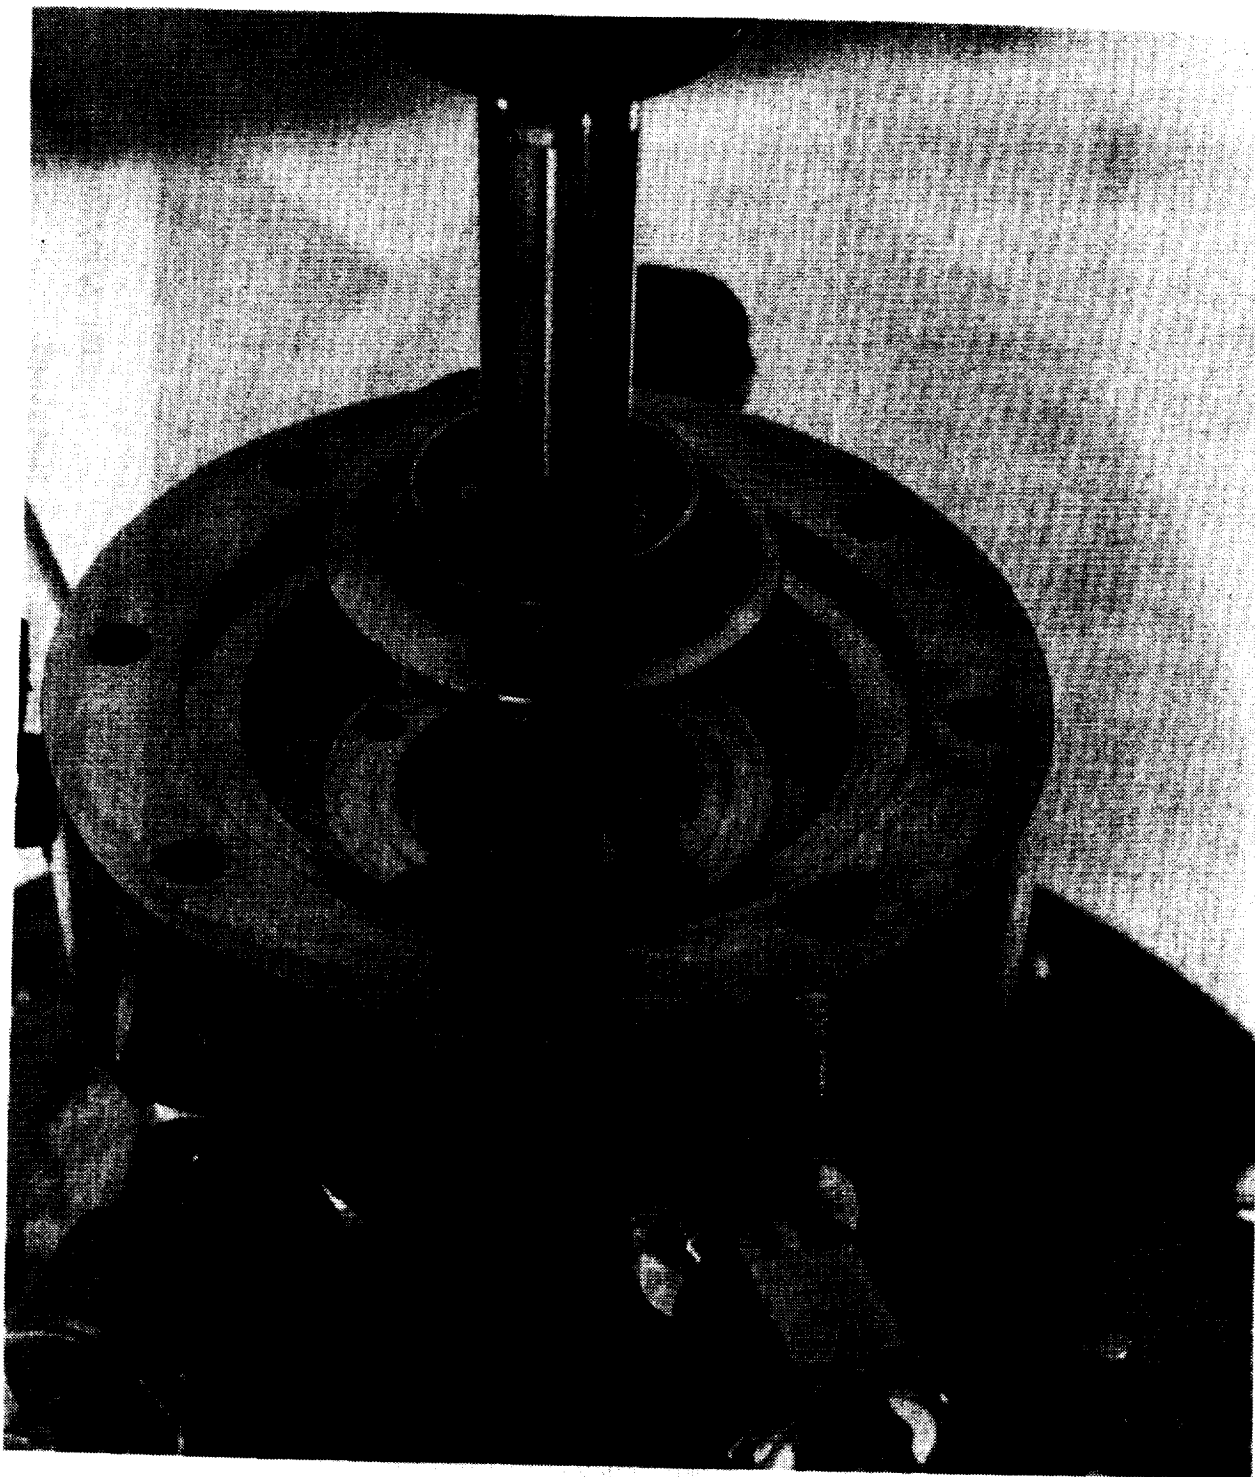
1XY55-6/23/70-C1J

Figure 7. Mark 36 Centrifugal Pump Impeller Installation

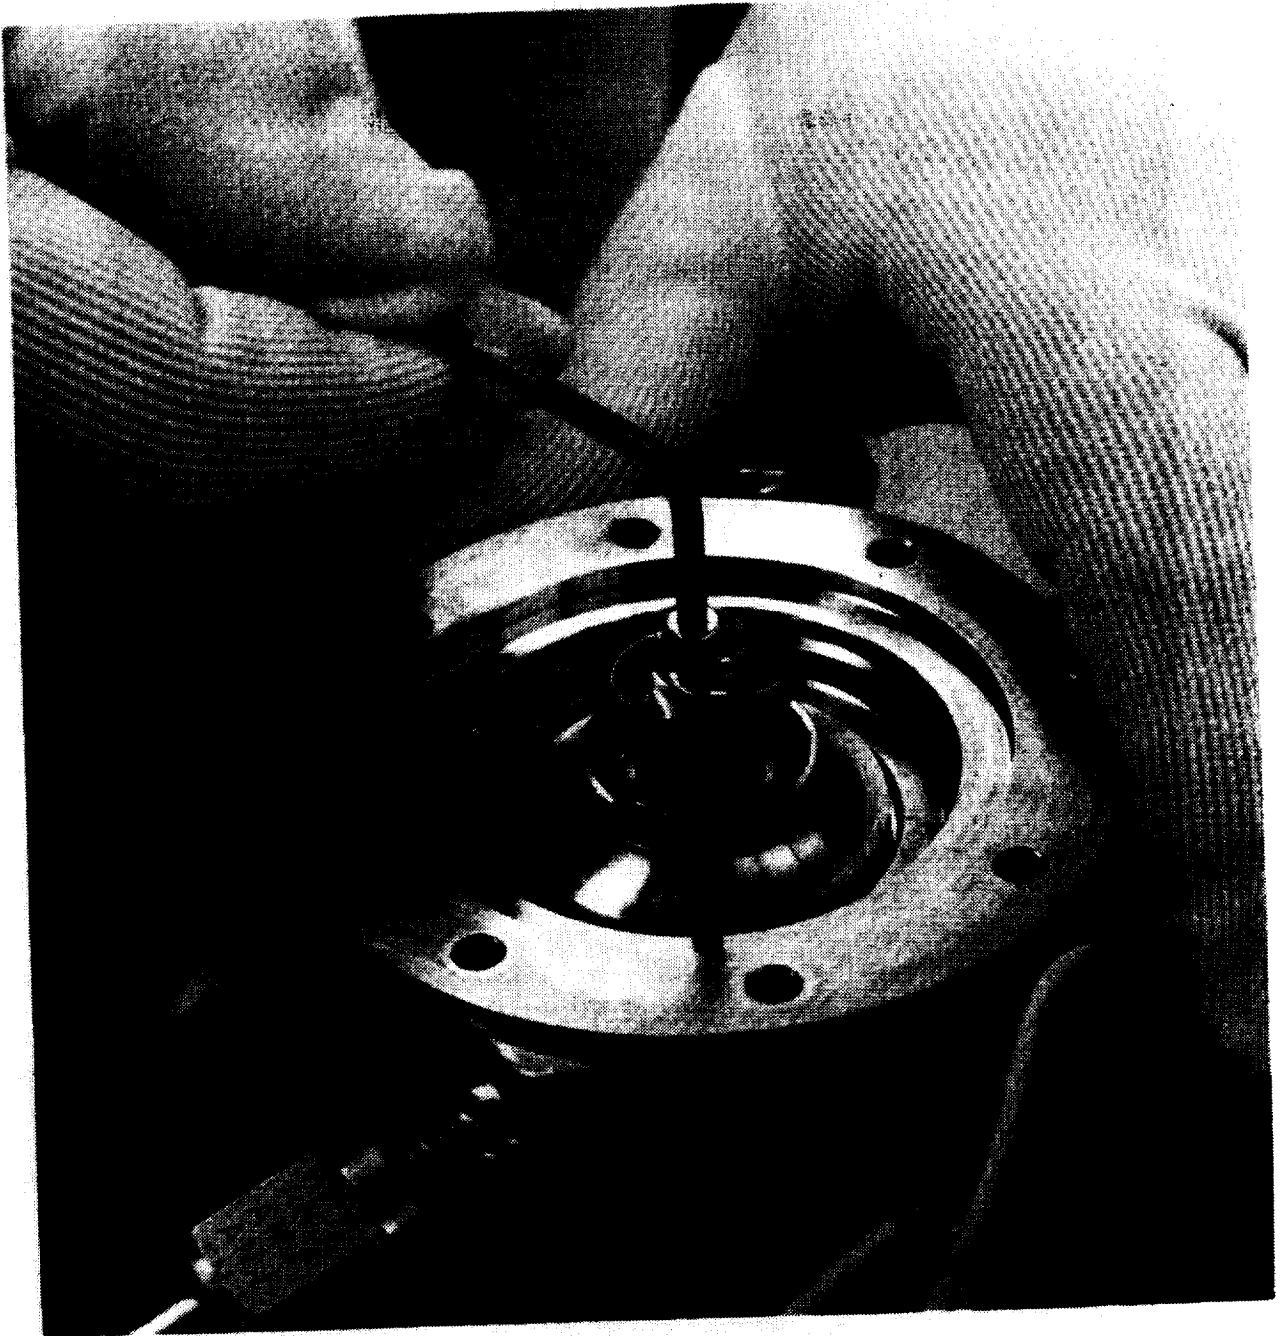
1XY55-6/23/70-C1H

Figure 8. Mark 36 Centrifugal Pump Inducer Installation

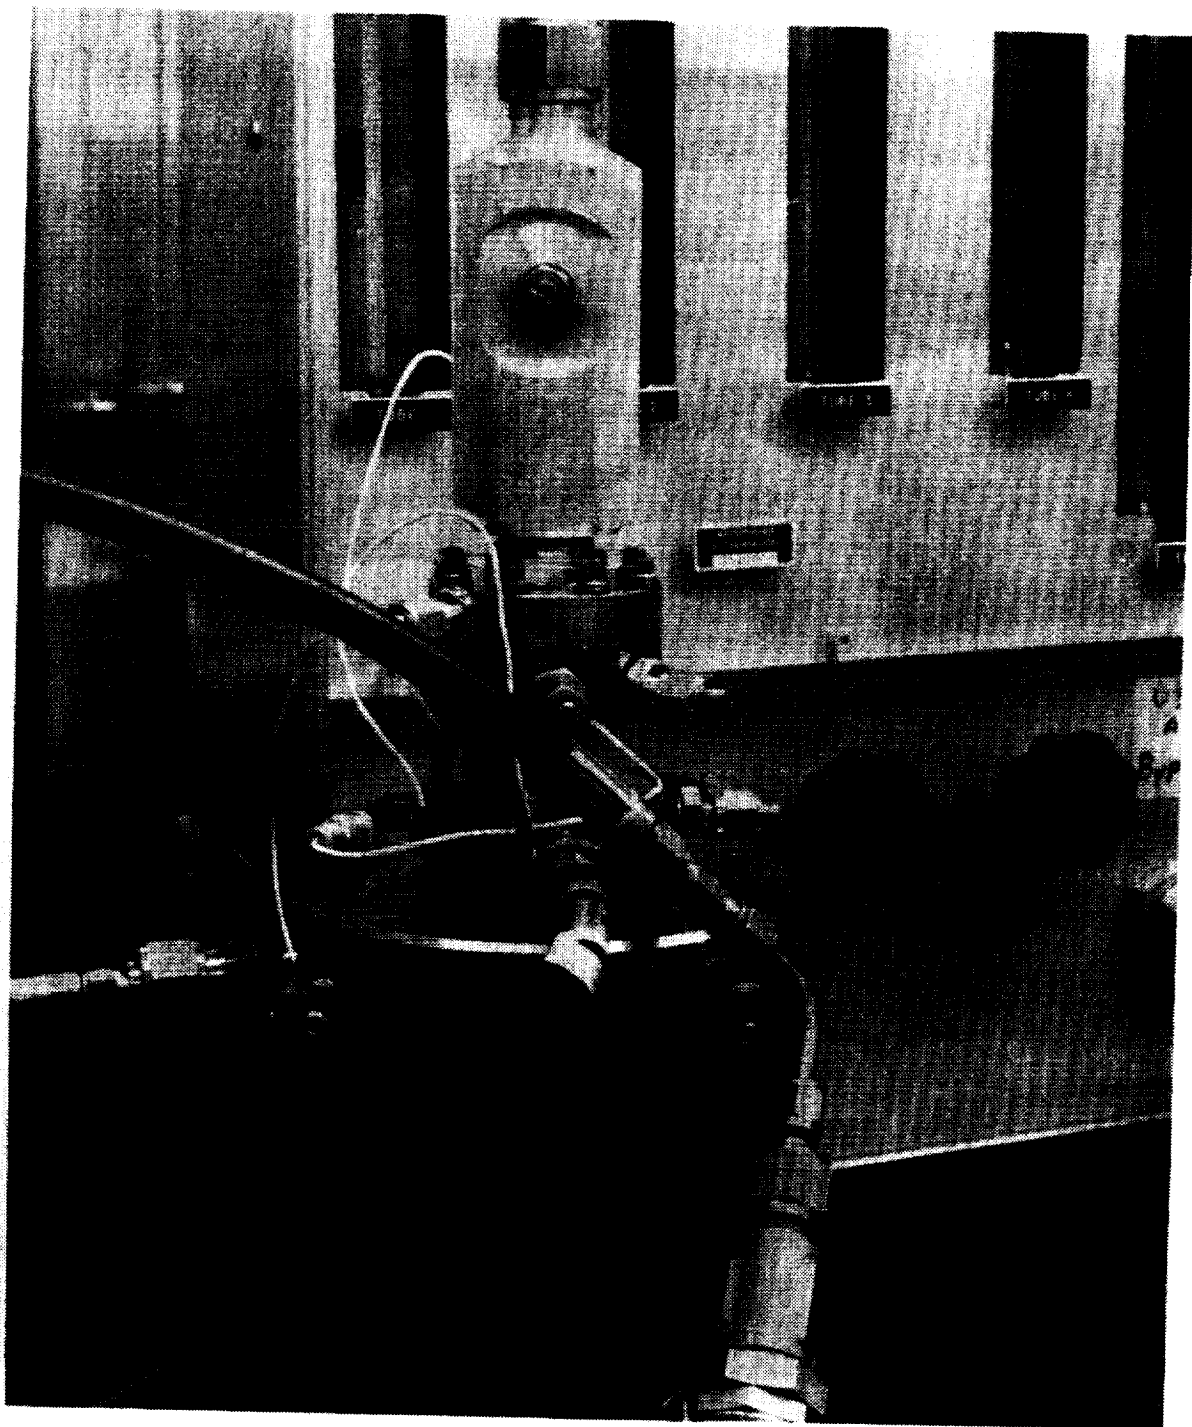
1XY55-6/23/70-C1 1

Ambient leak checks were conducted in which the leakage rates of the primary seal, intermediate seal, and turbine seal were measured when pressurized with gaseous helium to 30 psig ($.2 \times 10^6 \text{ N/m}^2$) (Fig. 9). The assembly was completed by installing the turbine disk on the shaft and fastening the turbine manifold on the pump housing. The breakaway and turning torque of the rotor was measured after assembly, at ambient pressure and temperature.

Figure 9. Mark 36 Centrifugal Pump Seal Ambient Leak Check

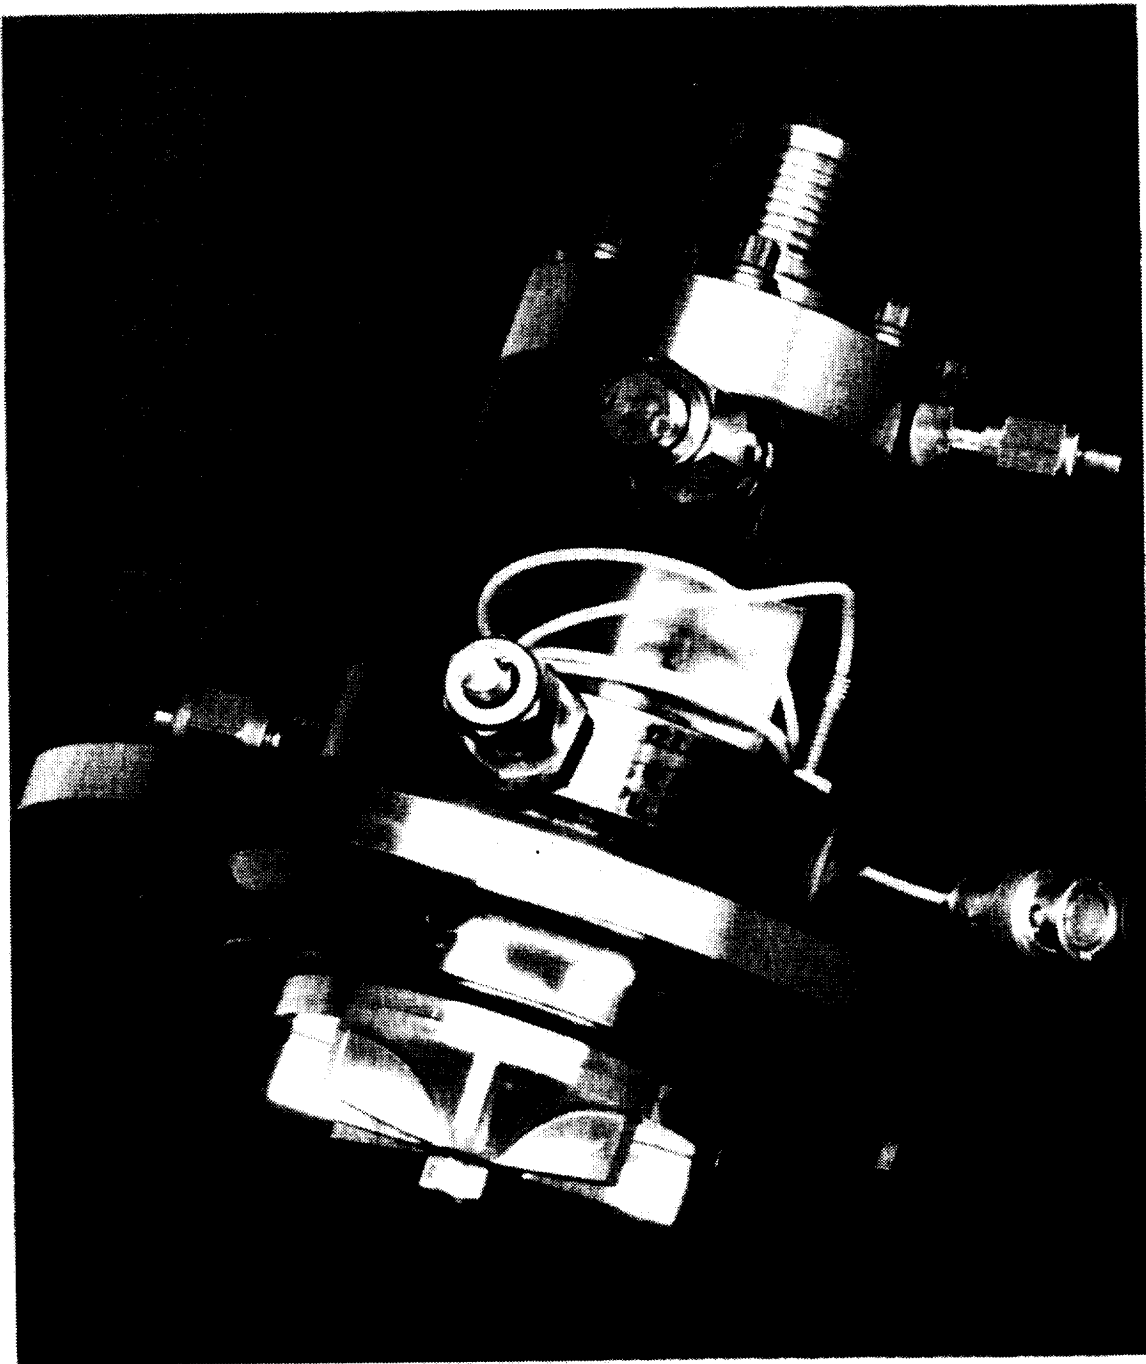
1XY52-5/22/70-CIA

The assembled pump minus the turbine manifold is shown in Fig. 10. The weight of the pump, excluding the turbine components and external fittings, was established at 10.4 pounds (46.2 N).

Figure 10. Mark 36 Centrifugal Pump With Turbine Drive

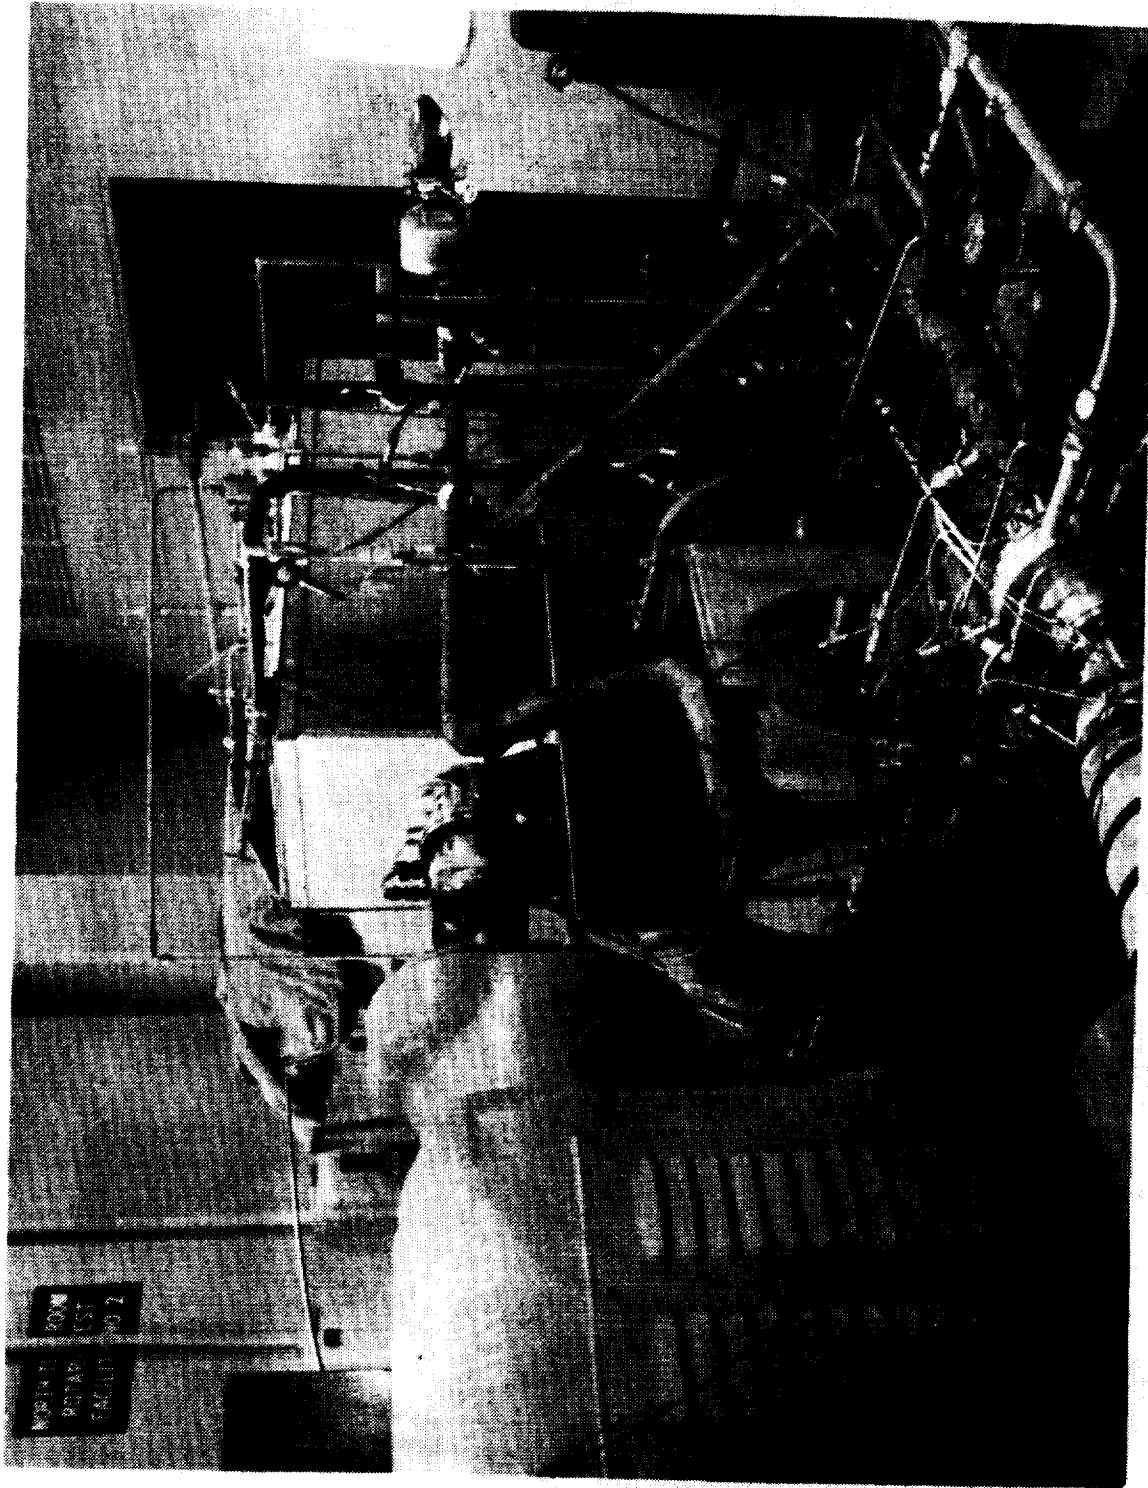
IXY56-6/22/70-C1A

Testing of the centrifugal pump with Freon-12 was accomplished in Rotary Test Cell #2 of Rocketdyne's Engineering Development Laboratory at Canoga Park, California. A schematic of the facility configuration is presented in Fig. 11. The pump installation in the test cell is shown in Fig. 12, 13 and 14.

Figure 12. Mark 36 Centrifugal Pump Freon 12 Test Facility

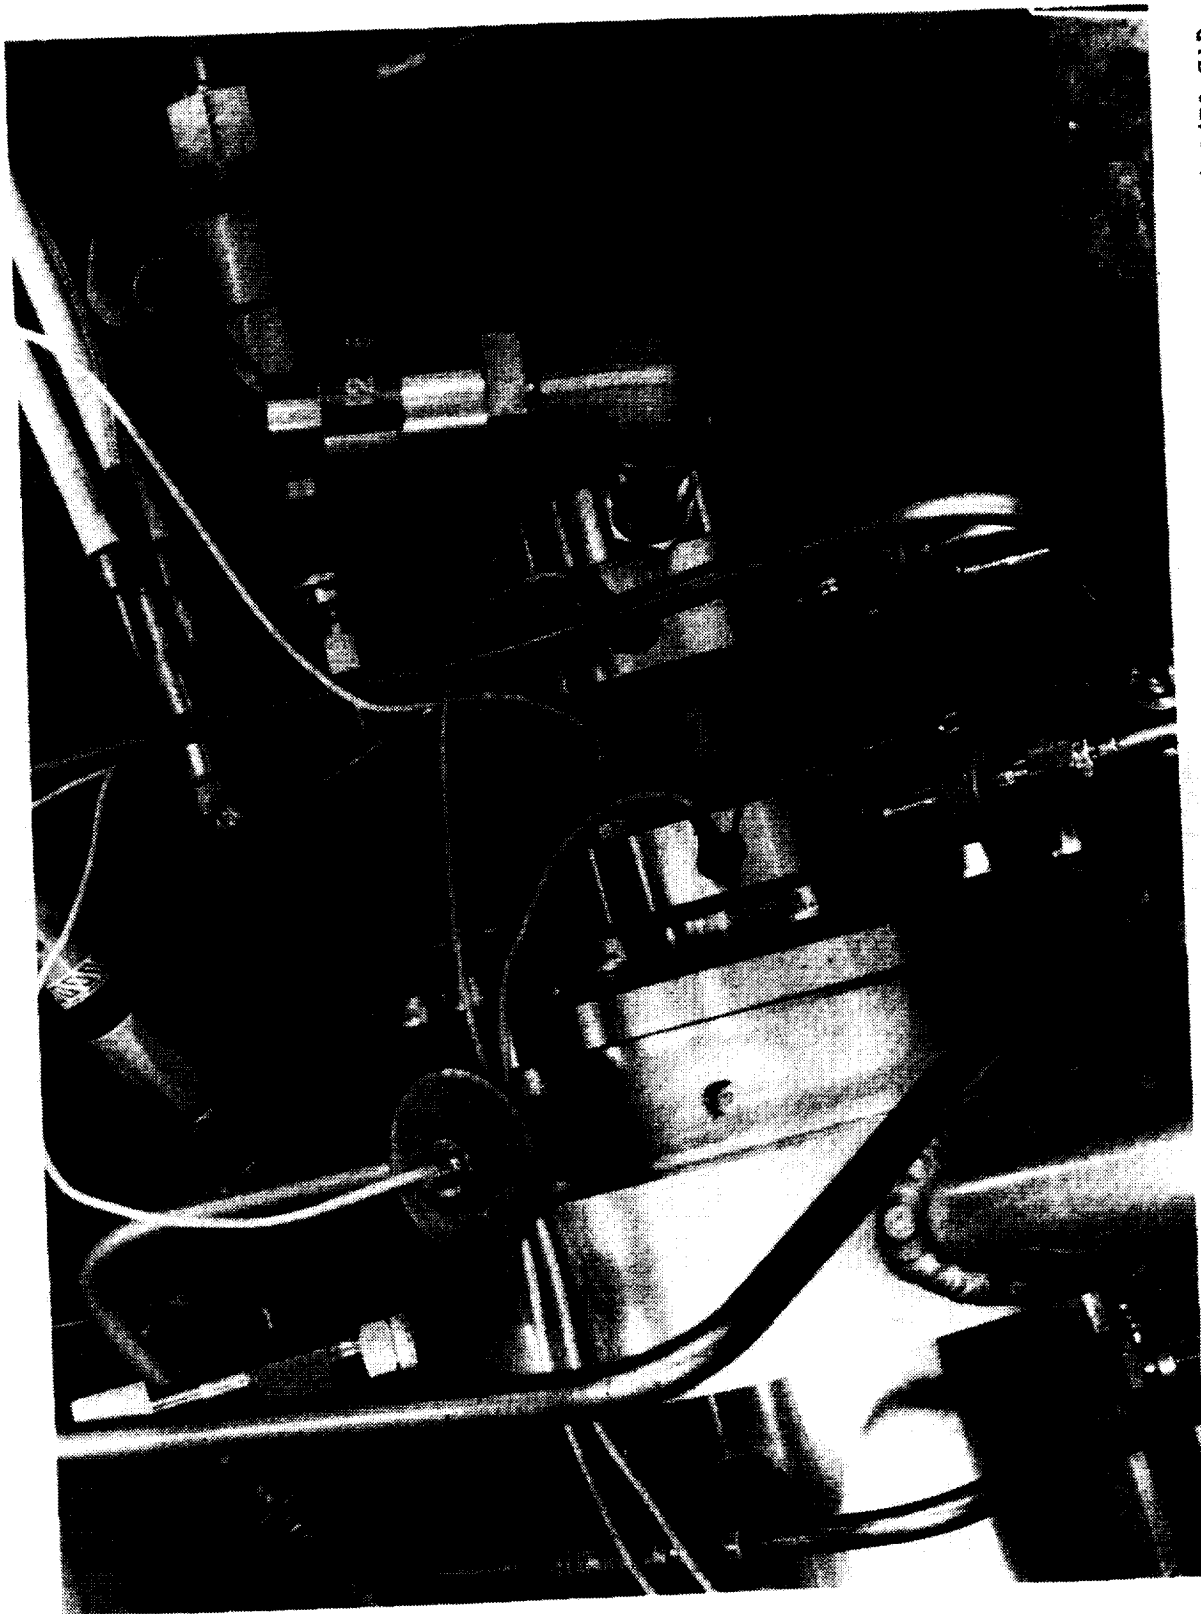
1XY56-6/22/70-C1B

Figure 13. Mark 36 Centrifugal Pump Installed for Testing With Freon 12
